Amazon Roundabout – a safety assessment for cyclists

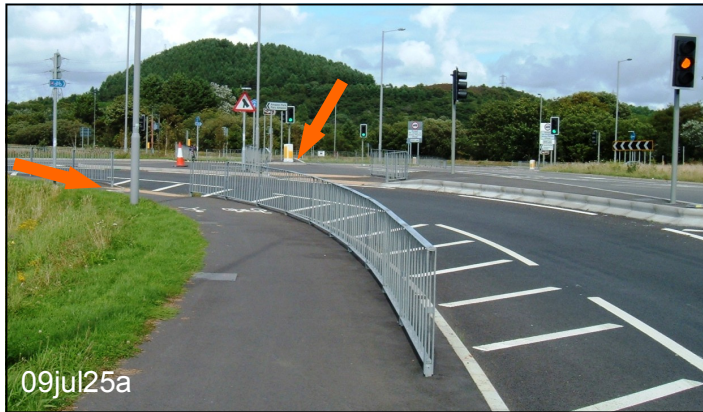
The first two crossings (arrowed) are for vehicles travelling to the Amazon warehouse. There is nothing to slow the traffic. At both of them cyclists have to look behind them, over their right shoulder, to see if the road is clear. There are no warning signs on the cycle path (such as “look right” for east bound cyclists).

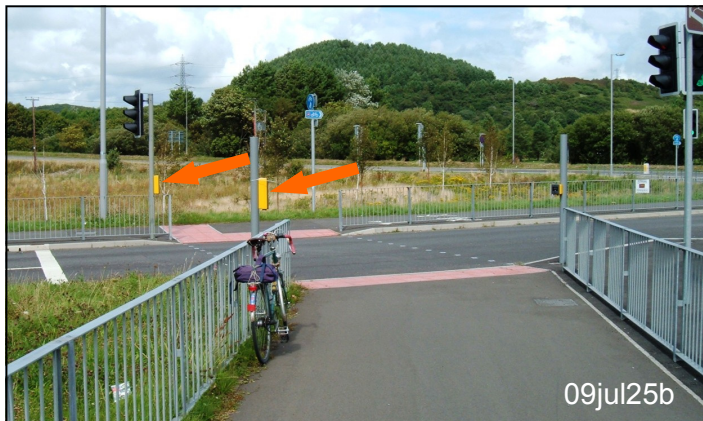
This shows the third crossing, the first with lights. The faces of the yellow control boxes (arrowed) are invisible to an eastbound cyclist. At least one should be turned so that a cyclist can see when it is safe to cross.

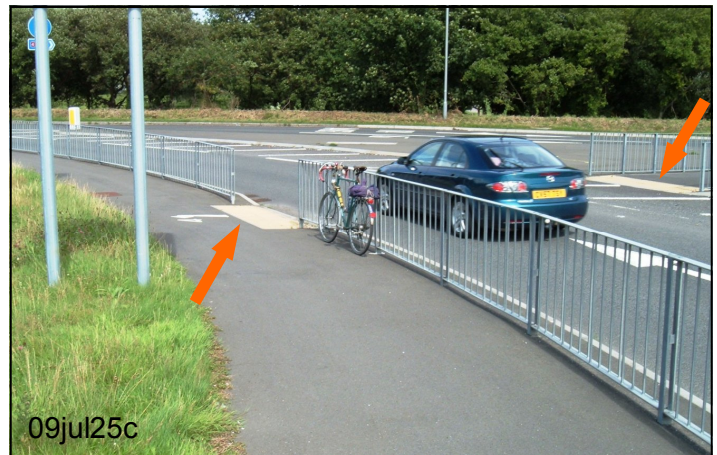
This is the fourth crossing (arrowed). The same comments apply as for crossings one and two. The blue car passed at speed and its approach could easily have been missed by an eastbound cyclist.

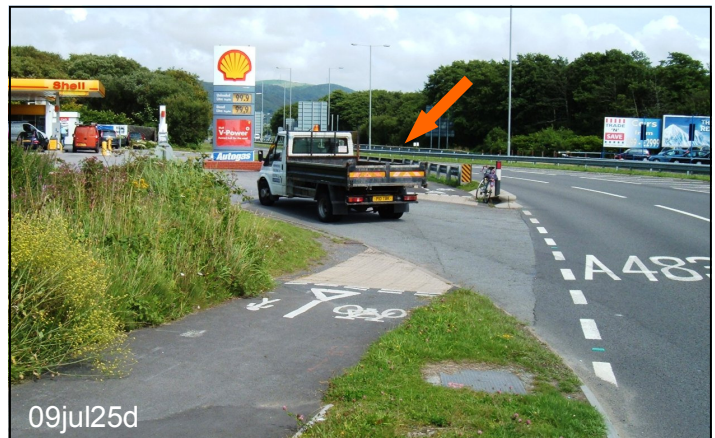
This Shell service station, immediately east of the junction, also poses a hazard to cyclists. As for crossings 1, 2. and 4 vehicles sweep across the path, as did the lorry (arrowed).
